NL-16-102

September 14, 2016

SUBJECT: Licensee Event Report # 2015-005-01, "Automatic Reactor Trip Due to a Turbine-Generator Trip Caused by the Trip of 345kV Main Generator Output Breaker 3 due to a Failure of South Ring Bus 345kV Breaker 5"
Indian Point Unit No. 3
Docket No. 50-286
DPR-64

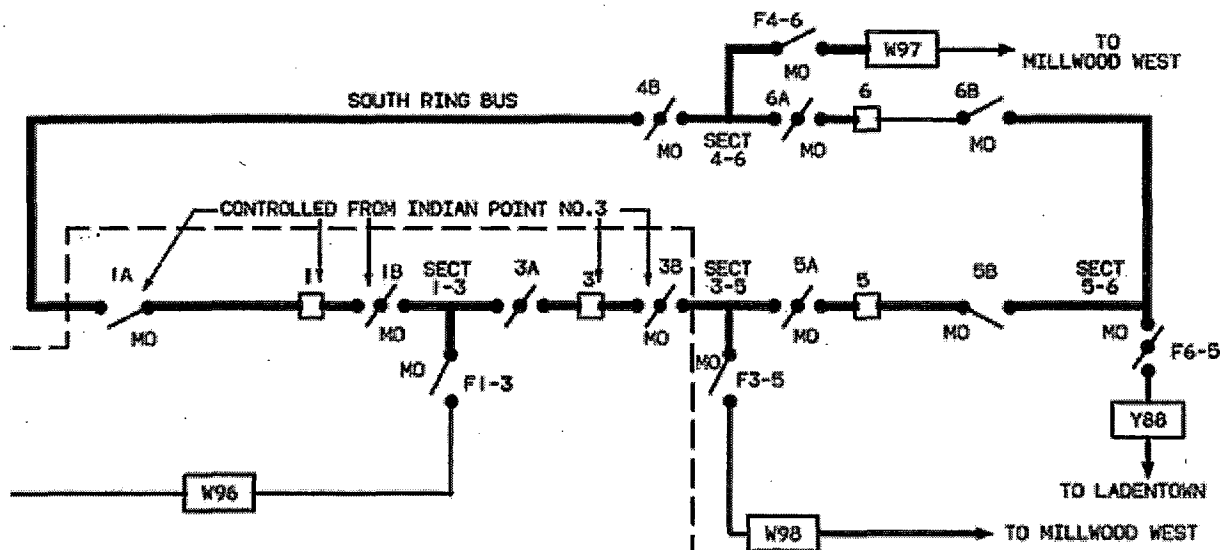
Figure of South Ring Bus at Buchanan 345kV Substation

The Unit 3 High Voltage Electrical Distribution System consists of the following subsystems: 1) 22kV system, 2) 345kV system, and 3) 138kV and 13.8kV system. The Unit 3 Main Generator supplies electrical power at 22kV through isolated phase bus to the two Main Transformers (MT). The MTs increase the voltage of the generator output to 345kV which is transmitted to the Buchanan Substation South Ring Bus via feeder W96. The Buchanan Substation contains two 345kV Ring Buses (North and South) and a 138kV bus. The South Ring Bus is normally supplied by Unit 3 and the North Ring Bus by Unit 2. The South Ring Bus is connected to the Millwood West Substation via two feeders, W97 and W98 and to the Ladentown Substation via feeder Y88. The South Ring Bus consists of four 345kV breakers, numbered 1, 3, 5 and 6. The 345kV breaker #5 was a Power Circuit Breaker, Type 345GA 25-30, SN 41-39006-2044, manufactured by ITE Imperial Corporation {I004} in 1971 and installed in 1973. This breaker is owned by Con Edison.

Direct cause of the RT was failure of Buchanan 345kV breaker 5 due to age-related degradation of the C phase contacts. This degradation was due to misalignment of the contacts that resulted in a hot spot due to high resistance. Con Edison who owned the breaker, determined the contact support system failed due to repeated cycling (fatigue failure). The failure of breaker 5 activated protective relays that opened the remaining Main Generator Output breaker 3 which initiated a trip sequence that resulted in an immediate Generator Trip, Turbine Trip and RT. The root cause was Indian Point Energy Center did not provide formal notification of industry operating experience (OE) to Con Edison. The specific incident pertains to the OE on ITE Type GA breakers that could impact IPEC generation. The condition was exacerbated by the OE process (EN-OE-100) that did not have a trigger for formal communication of important OE information to external groups that control and own equipment critical to IPEC generation.

- A detailed inspection and failure analysis of 345kV breaker 5 was performed by Con Edison to identify the specific failure mechanism and root cause. The Con Edison results were discussed with Entergy and a Root Cause Evaluation performed that included the results obtained from Con Edison.
- 345kV Breaker 5 was replaced by Con Edison.
- Procedure EN-OE-100 (OE Program) was revised by including a new section describing how to initiate formal notification to external groups when OE related to components they own and/or control can affect generation.
- A new IPEC site procedure was prepared (SMM-LI-126) that formalizes the process for notifying external groups of operating experience that can affect generation at IPEC.
